Engineered Cementitious Composites for the Conservation of 20th Century Concrete Architectural Heritage

Antroula Georgiou^{1,a*}, Michalis Theodoulides^{1,b} and Ioannis Ioannou^{1,c}

¹Department of Civil and Environmental Engineering, University of Cyprus

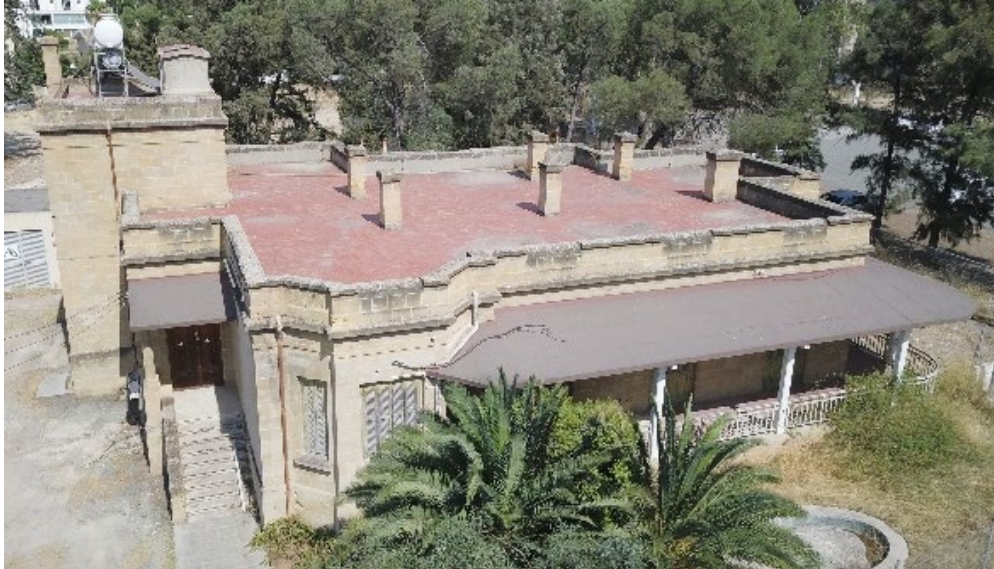
Figure 1: Aerial photo of the case study building.

This research assesses the use of ECC jacketing on historic low strength concrete, through cover replacement. Initially, a historic case study structure (Fig. 1) built in accordance with the Hennebique patented system in Cyprus, with reinforced concrete structural members and load bearing masonry walls, was investigated and assessed under seismic loading. The seismic assessment revealed the structural deficiencies of the case study building structural members. The properties of the original concrete material were then used to define a new, equivalent low strength concrete to be subjected to

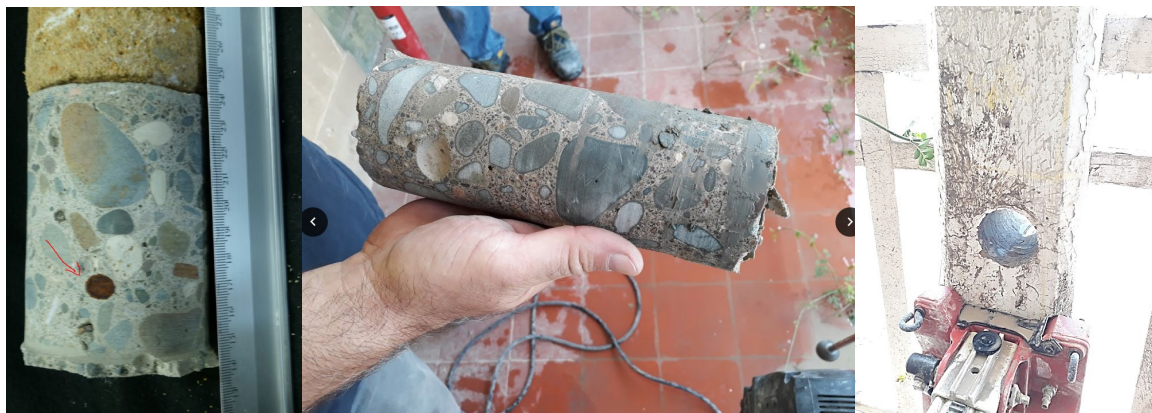
Figure 2: Left: Core sample taken from basement ceiling slab with reinforcement embedded in it. Middle: Core sample taken from column. Right: Location of core sampling from column.

In-situ investigations. An extended in-situ investigation was performed, aiming initially at the verification of the geometry of the structural members. Since only some of the original construction detailing drawings were found, comprising mainly the slab reinforcement, a rebar detector (PROCEQ) was used to (i) verify the slab reinforcement in relation to the original drawings, and (ii) detect the steel reinforcement, rebar cover and diameter in the beams and columns. The detection of the reinforcement position was also used to determine the locations for the non-destructive rebound tests (EN 12504-2) and the possible positions for core sampling of concrete (EN 12504-1) [26]. The number of core samples had to be limited, due to the fact that the building is listed. For this reason, core samples were taken only from a column, a single location at the basement ceiling slab and another location at the ground floor roof slab (Fig. 2).

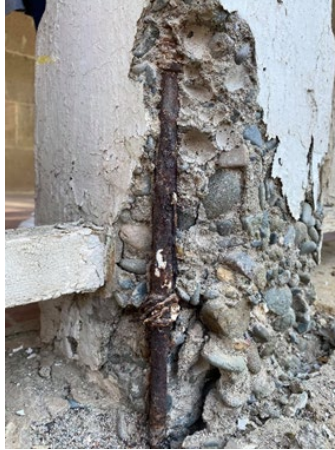
Figure 3: Cover delamination and rebar corrosion on exposed column.

reinforcement of the columns, based on the exposed element (Fig. 3) and on a series of measurements with the rebar detector was found to be in the order of 5/8" (15.875 mm), since inches were used at that time for bar sizing, while no stirrups were used to confine the longitudinal bars (besides some thin wires to hold them in place during casting). This is in agreement with detailing plans found in the literature [27].

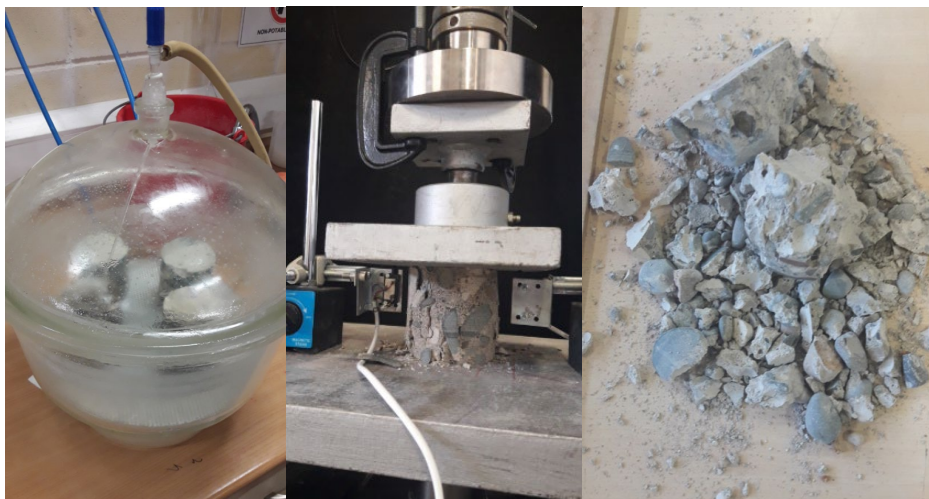
Figure 4: Tests on concrete. Left: Specimens for porosity measurement in the vacuum vessel. Middle: Testing apparatus for concrete compression. Right: Failure of concrete specimen in compression.

Laboratory investigations. The following tests were carried out in the lab on the concrete specimens collected in-situ: (a) dry mass, density and porosity, by vacuum assisted water absorption, and (b) uniaxial compression (EN 12390-3 [28]) (Fig. 4). The samples showed low variability in the test results, even though concrete at the time the building was constructed was manually mixed on site in small batches. The average apparent density was found to be 2192 kg/m³, while the open porosity was 18.3%. The average compressive strength was 15.21 MPa, resulting from samples with aspect ratio 1:1 (i.e., equivalent to mean cube strength), with the lower value of 13.92 MPa obtained from the roof slab, and the maximum of 17.11 MPa obtained from the column sample. The maximum (natural) aggregate size from the samples tested was recorded as 52 mm, though most samples included aggregates of much smaller diameter. Visually, the mix design showed no apparent voids or cracks, even though at the time there were no mechanical means for concrete compaction.

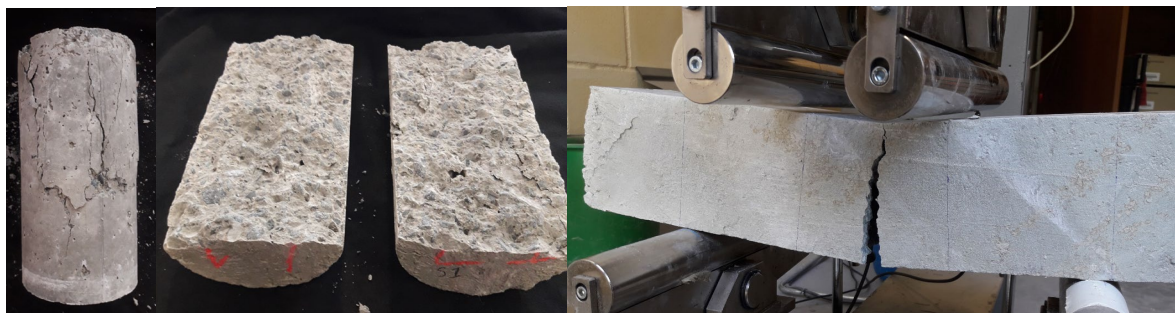
Figure 6: Top: Compressive stress-axial strain-lateral strain of LSC specimens. Bottom: Failure patterns under uniaxial compression (left), split cylinder (middle) and four-point bending (right) tests.

A.1 Low strength concrete. Tests were conducted on the LSC in order to acquire the compressive strength and indirect tensile strength of the material. The compressive strength and strain at maximum compressive stress, the split cylinder tensile strength, and the flexural strength under four-point bending are recorded in Table 3, together with the average values and standard deviations of the results. The stress-strain, both axial and lateral, under uniaxial compression, and the failure patterns are depicted in Fig. 6.

Specimen	$f_{c,max}$ (MPa)	ϵ_o	Specimen	$f_{t,sp}$ (MPa)	Specimen	f_{fl} (MPa)
L1-C1	9.69	0.00445	L1-S1	1.195	L1-B1	2.101
L1-C2	9.32	0.00749	L1-S2	1.437	L1-B2	2.349
L1-C3	11.64	0.00460	L1-S3	1.569	L1-B3	2.200
Average	10.22	0.0055		1.40		2.22
Stand. Dev.	1.64	0.0020		0.09		0.11

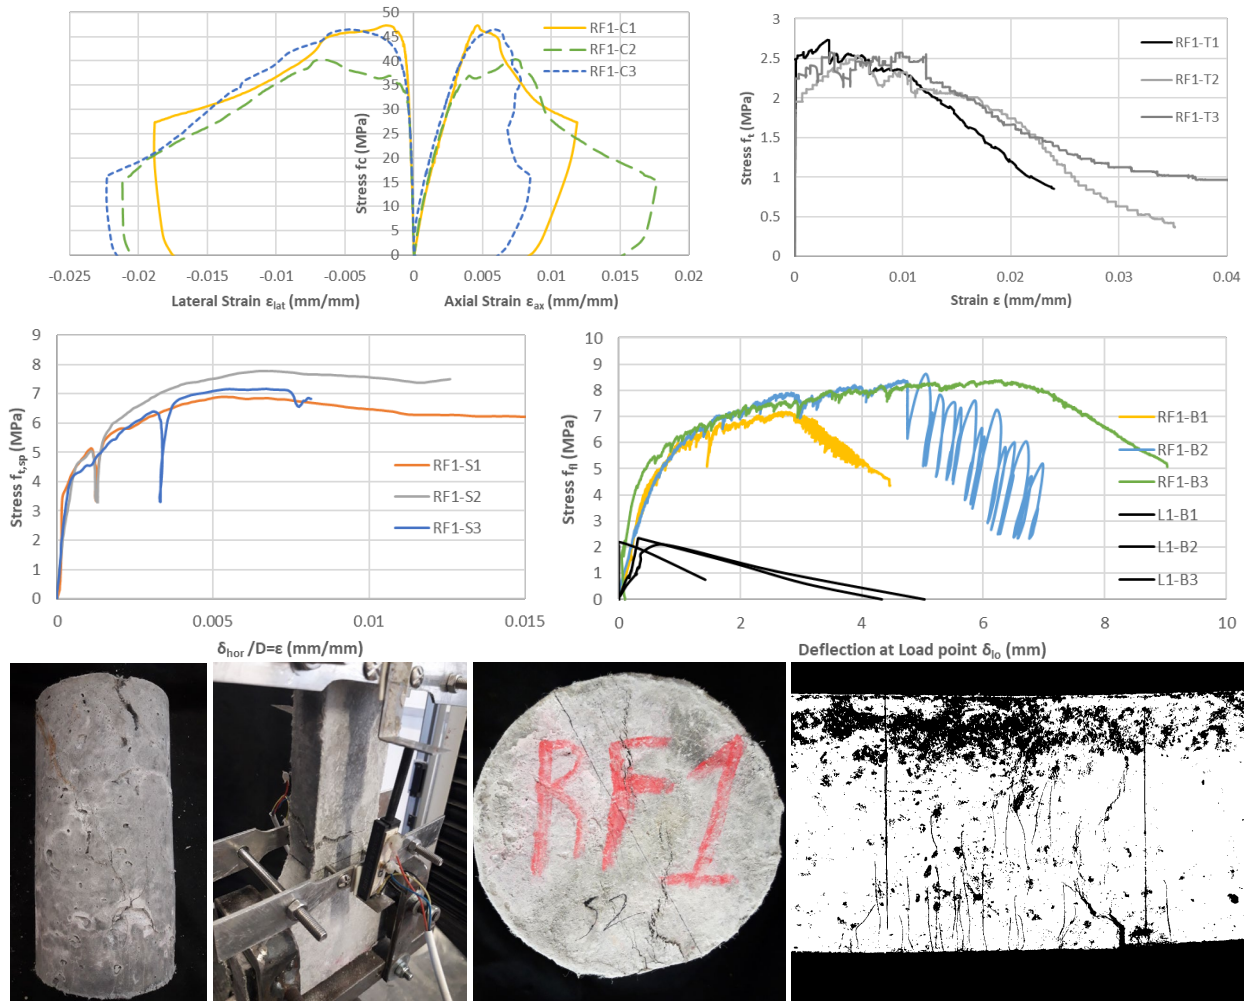
Figure 7: Top row: Compressive stress-axial strain-lateral strain (left) and uniaxial tension stress-strain curve (right) of ECC specimens. Middle row: Split cylinder stress-horizontal strain (left) and four-point bending stress-load point deflection (right) of ECC specimens. Bottom row: Failure patterns of ECC specimens.

A.2 ECC jacket for repair. For the characterization of the behavior of the ECC jacket material, uniaxial compression, tension, split cylinder and four-point bending tests were performed, resulting in the stress-strain curves of Fig. 7. The ECC material exhibited strain hardening behavior, with an ultimate tensile strain prior to crack localization in the order of 1%. The uniaxial tensile stress obtained was ca. 2.5 MPa. The strain hardening behavior was extrapolated to the indirect tensile tests of split cylinder and four-point bending that also exhibited multiple cracking, large deformation capacity, increase of strength after first cracking and high energy dissipation. Additionally, in the uniaxial compression tests, failure was delayed with a shift of strain at peak load, and low lateral

deformations, due to the confinement action of the fibers bridging vertical cracks; this is typical of strain hardening fiber reinforced cementitious composites [35].
