UNREINFORCED MASONRY WITH EMBEDDED IRON TIE-RODS –
THE CASE OF PANAGIA FANEROMENI CHURCH, CYPRUS

M.Sc. DISSERTATION

DEPARTMENT OF CIVIL AND ENVIRONMENTAL ENGINEERING

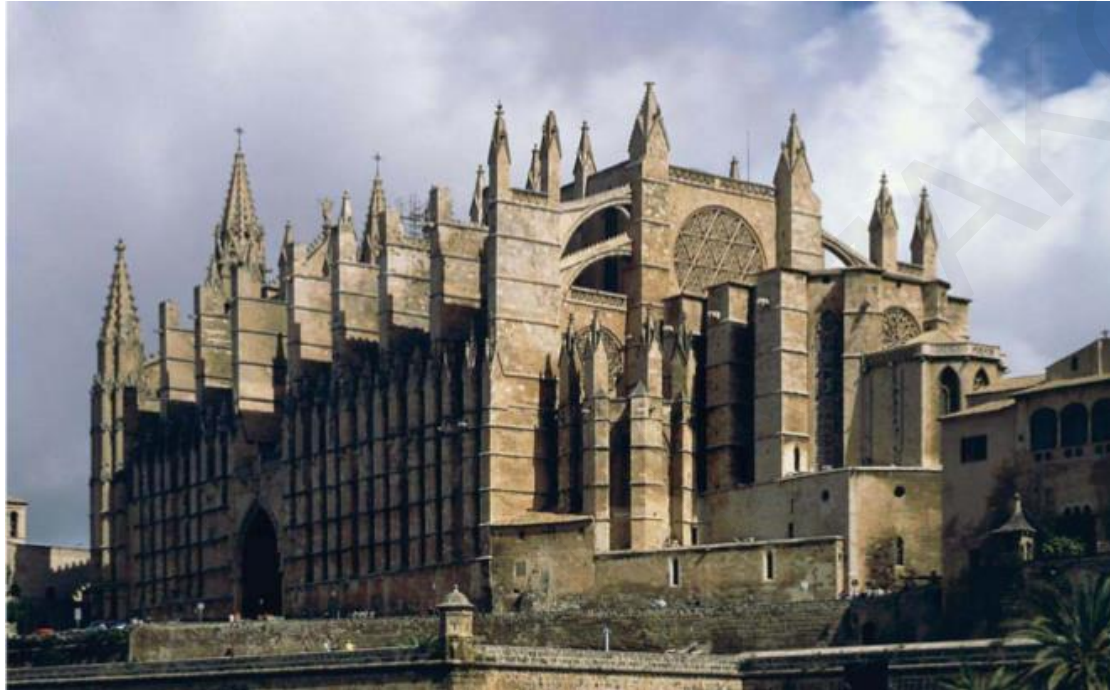
Santa Maria De Palma de Mallorca is a cathedral constructed over three hundred years ago, located in Spain (Luca Pel à J. B., 2016). Mallorca Cathedral is one of the most characteristic monuments of Gothic style in Mallorca (**Figure 4**).

Figure 4 Cathedral Of Mallorca (Luca Pel à J. B., 2016)

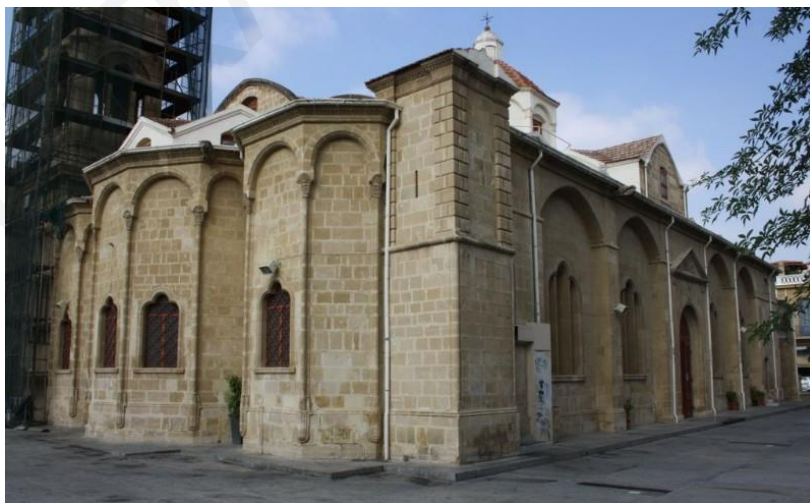
Church of Panagia Faneromeni (**Figure 18**) is an old masonry building located in Nicosia's, Cyprus' capital, historic centre. It is the biggest church inside the historic Venetian Walls of Nicosia. Initially, in 1222, when first constructed was a women Monastery. In 1561 Cyprus Island was under Ottoman Empire, and the Monastery would have become a mosque, as many other churches in Cyprus. Ottoman gave up their efforts when assigned imams kept losing their lives and the church remained as it was. In 17th Century a big earthquake caused damages in many structures in Nicosia including Faneromeni Church. Faneromeni Church after the earthquake needed to rebuild. Reconstruction of the Church was from 1872 to 1874 and maintains its appearance until today (Cyprus for Travellers, 2020). Until today Faneromeni Church has been a significant structure for the town and one of the most emblematic building in Nicosia. Faneromeni church is a three-aisled dome basilica with cross-shaped vaults, but it has also an influence from gothic style cathedrals. Innovative intervention for the era of its construction are the iron elements connecting the arches of the church called tie-rods. Faneromeni is considered as the first building in Cyprus that these elements were used, and they were placed during construction and not as an addition to a postnatal stage. These kind of iron elements, as mentioned in Chapter 2, were used both in Europe and Middle East countries. Assured assumptions about how this technique came to Cyprus and where the builders learnt about the effectiveness of these elements cannot be made.

Figure 18 Faneromeni Church, exterior (Big Cyprus, 2020)
