## Seismic assessment of historic concrete structures: The case of Pedieos Post Office in Nicosia, Cyprus

Antroula Georgiou<sup>\*</sup>, Marios Georgiou, Ioannis Ioannou

Department of Civil and Environmental Engineering, University of Cyprus, Kallipoleos 75, Nicosia 1678, Cyprus

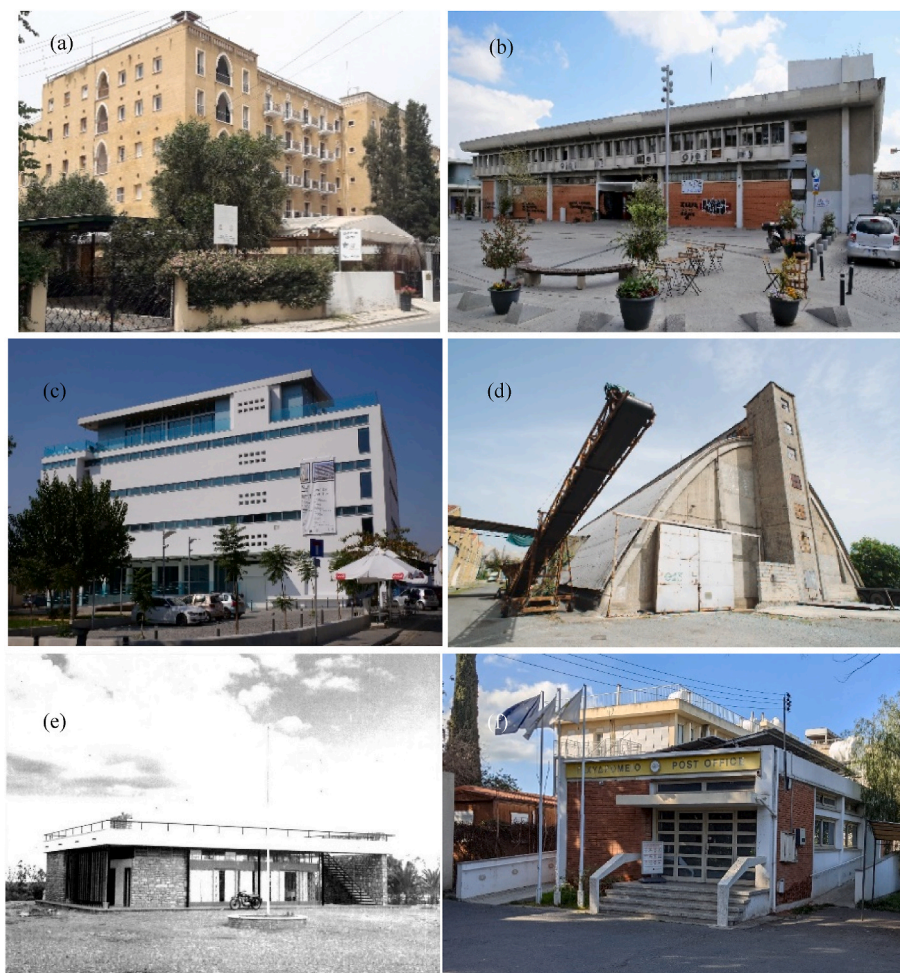
**Fig. 1.** Historic concrete structures in Cyprus: (a) Ledra Palace Hotel, Nicosia, (b) Nicosia Municipal Market, (c) SPEL, Nicosia, (d) Carob store, Limassol, (e) Pavilion at Hala Sultan Tekke, Larnaca (f) Pedieos Post Office, Nicosia.

Some examples of large-scale urban buildings, built with reinforced concrete in Cyprus, are the well-known historic Ledra Palace Hotel (1947–1949) (Fig. 1a), the Nicosia Municipal Market (1965) (Fig. 1b), and the offices of SPEL (1954) (Fig. 1c) in Nicosia. An example of an industrial reinforced concrete building on the island is the carob store in Carnagio, Limassol (1961) (Fig. 1d), while an example of a single building constructed with reinforced concrete is the Pavilion of Hala Sultan Tekke in Larnaca (Fig. 1e), which is part of the larger Hala Sultan Tekke Muslim monument complex. All the above buildings have been listed, as opposed to a large number of smaller individual urban buildings, which nevertheless make up a large portion of the infrastructure of Cyprus and are certainly part of the history of the island. One such building is the Pedieos Post Office in Nicosia, which was built in 1964 (Fig. 1f).

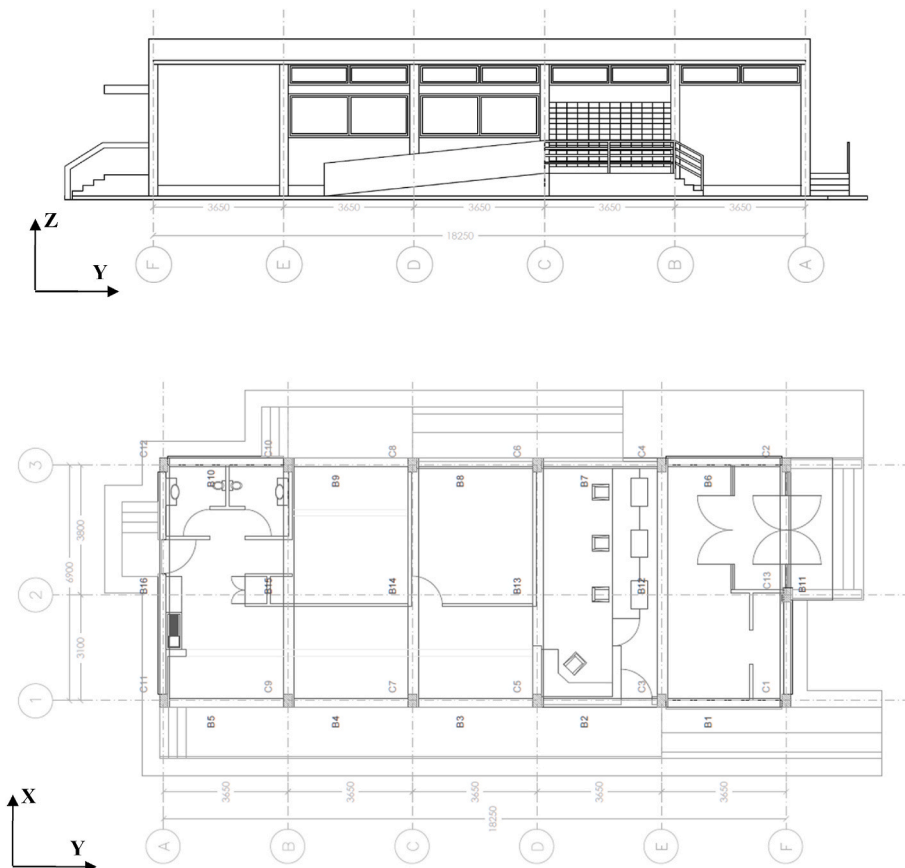
Fig. 2. Side (top) and Plan (bottom) view of the Pedieos Post Office.

The building is of rectangular shape (Fig. 2), and comprises reinforced concrete frames with beams and columns, with total plan dimensions measuring  $18.25 \times 6.90$  m, and a net height of 3.75 m. It consists of a vestibule with a parcel counter and a small letter collection room, a corridor leading to an office, a storage room and ancillary areas (kitchen and toilets). At the entrance, there is a small cantilever providing shading, whilst on the upper part of the perimeter of the building there are skylights (Fig. 2). The post office is partially elevated, so there are stairs to the entrance. To the left and right of the latter, there are two ramps leading to the private mailboxes. Besides the main entrance, there are two more doors, one on the west and one on the north side of the building.

The structural system shown in Fig. 2 consists of thirteen columns with dimensions  $400 \times 250$  mm, and two types of beams with dimensions  $600 \times 250$  mm and  $450 \times 300$  mm, in the Y and X directions, respectively. From the on-site inspection, a slab thickness of 15 cm was measured, both for the cantilever and for the slabs. There are also twelve metal drainpipes passing through the core of the columns.

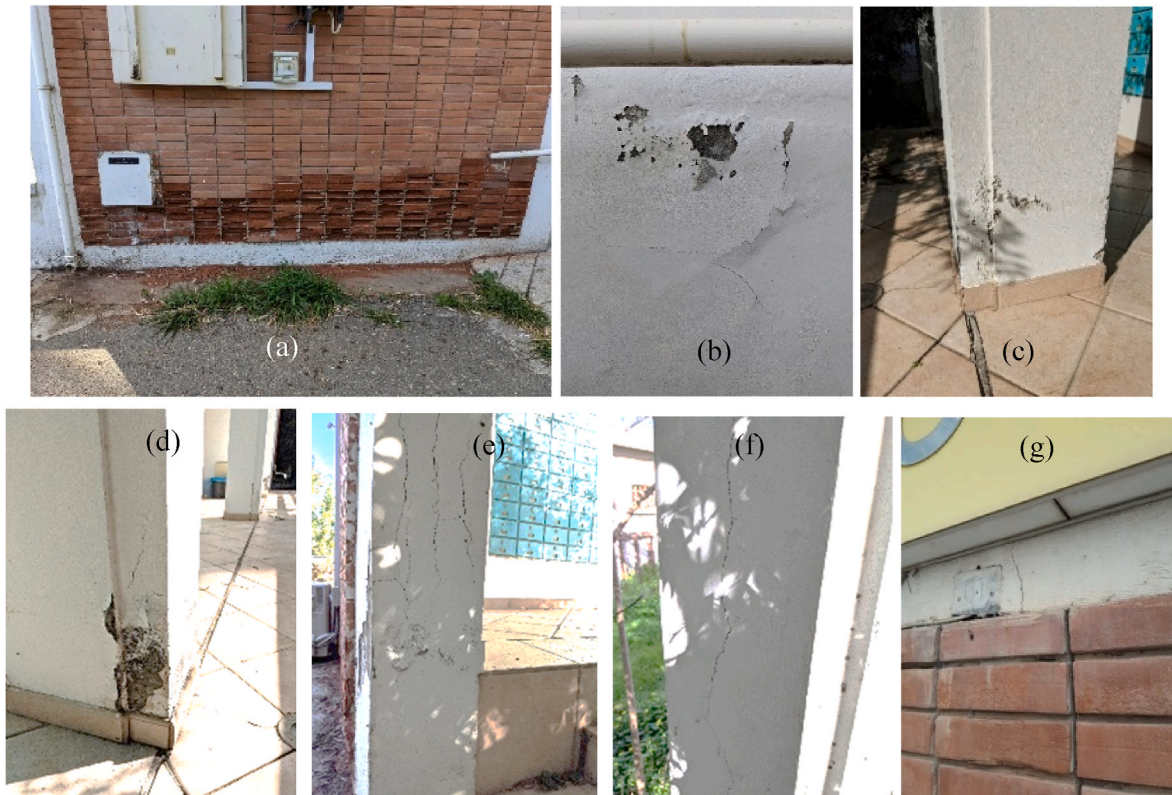
**Fig. 3.** Building pathology: (a) rising damp and salt crystallization damage to the fired red clay solid brick facade, (b) plaster detachment on painted infill walls, (c and d) plaster detachment on columns, (e and f) longitudinal cracks due to corrosion of the reinforcement, (g) vertical crack at the center of the entrance beam. (For interpretation of the references to colour in this figure legend, the reader is referred to the Web version of this article.)

Rising damp can be observed around the lower part of the masonry infills of the building, resulting to significant loss of the masonry material (fired red clay solid brick) and detachment of plaster (Fig. 3a–d). The loss of rebar cover in the reinforced concrete elements is also evident. It is worth noting that the on-site concrete mixing practice in small batches, the lack of compaction equipment, and the low strength of the cement of the time (Georgiou et al., 2021), together with the honeycombing and concentration of aggregates observed at the base of the columns, suggest the existence of low quality concrete. In some columns, there are cracks parallel to the longitudinal axis of the elements, indicating corrosion of the longitudinal reinforcement (Fig. 3e–f). Small cracks are also observed in various other parts of the structure, such as beams (Fig. 3g) and columns. It is important to mention that, during the site visits, it was observed that rainwater flows through metal drainpipes embedded in the core of the corner concrete columns. Therefore, through potential leaks from these pipes, moisture is allowed to enter the load-bearing elements, with detrimental effects.

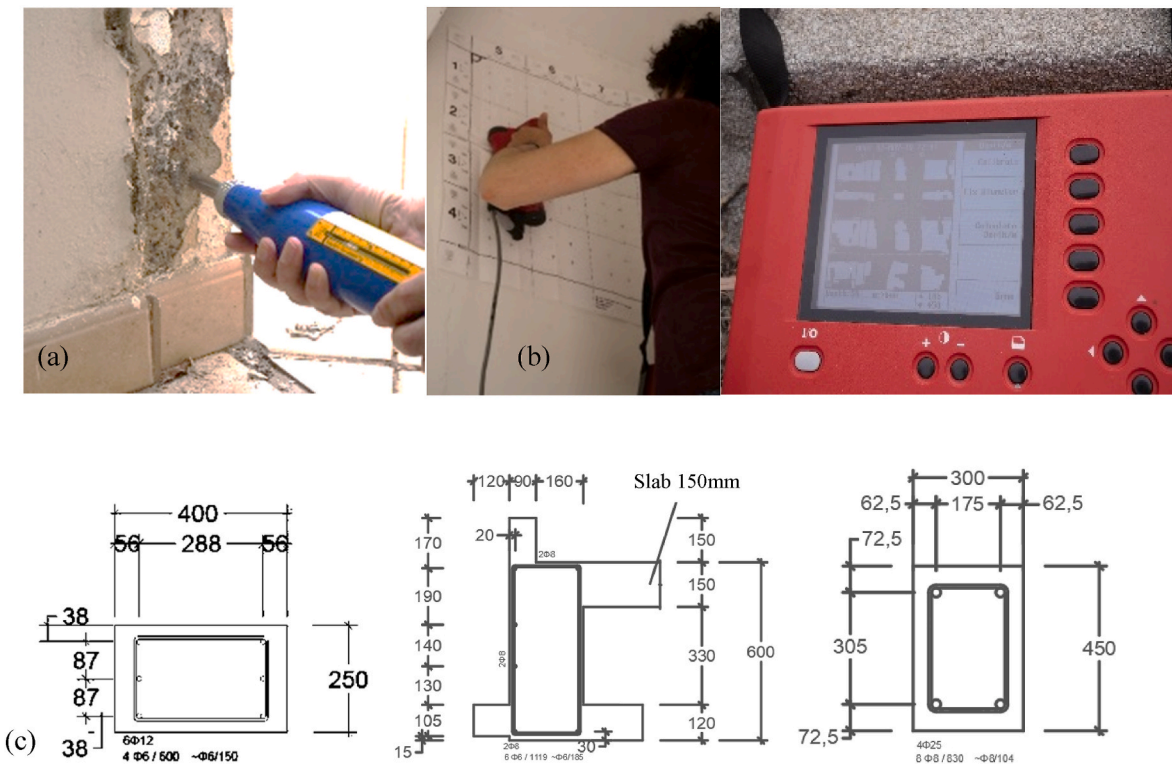
**Fig. 4.** (a) Schmidt rebound hammer test on column, (b) rebar detector, (c) column and beams detailing.

In order to collect data regarding the detailing of the structural members and the material properties, non-destructive tests were performed by the use of Schmidt rebound hammer and rebar scanner (Fig. 4).

study to determine the position, depth and size of the reinforcement. For the correct scan of the reinforcement, a grid printed on large surfaces of paper was used; this was placed on the surface of the member to determine the path to be followed by the scanner. Scans were carried out in both horizontal and vertical paths (Fig. 4b) at various representative points of the building, such as end-columns, beam ends in X and Y direction, interior beams and roof slab. Fig. 4c shows the detailing of the columns and beams, as measured. The results show that the building is detailed with small sections of reinforcement, as expected due to the design practices of the era, which took into account only vertical loads.

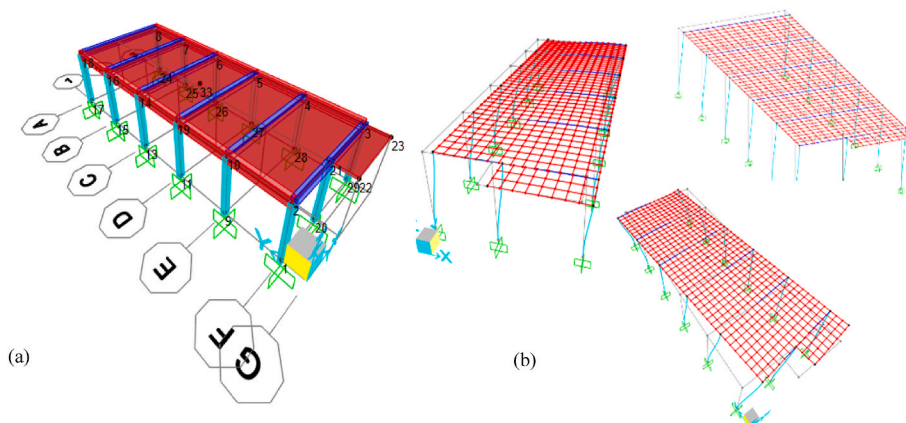
Fig. 5. (a) Model of the structure, (b) 1st, 2nd and 3rd mode shapes.

The structure was modeled in SAP2000 (CSI, 2009), with linear frame elements for the beams and columns and shell elements for the slabs (Fig. 5a). The compressive strength of the materials was set as 16 MPa, based on the low knowledge level obtained. The frames' stiffness was reduced to half the value of the of the uncracked frames, in order to take into consideration stiffness at yielding during the seismic event (EN1998-3, 2005). The columns were connected rigidly to the ground and the nodes of the slab were assigned with diaphragmatic action. The dead and live loads were added to the self-weight of the slab ( $2 \text{ kN/m}^2 + 0.35 \text{ kN/m}^2$  and  $3 \text{ kN/m}^2$ , respectively (CYS EN1991:1, 2007)). The vertical loads, combined with the seismic action, were  $G+0.3Q$ . Mode shapes are depicted in Fig. 5b and corresponding periods in Table 1. The first three modes of the structure, with periods  $T_1 = 0.76 s$ ,  $T_2 = 0.52 s$  and  $T_3 = 0.43 s$ , are much larger than those that would have been obtained by current practices, due to the very slim vertical members that were designed in previous eras.

Mode	Period (sec)
MODAL-Primary X	1	0.759793
MODAL-Primary Y	2	0.519718
MODAL-Torsion	3	0.433454

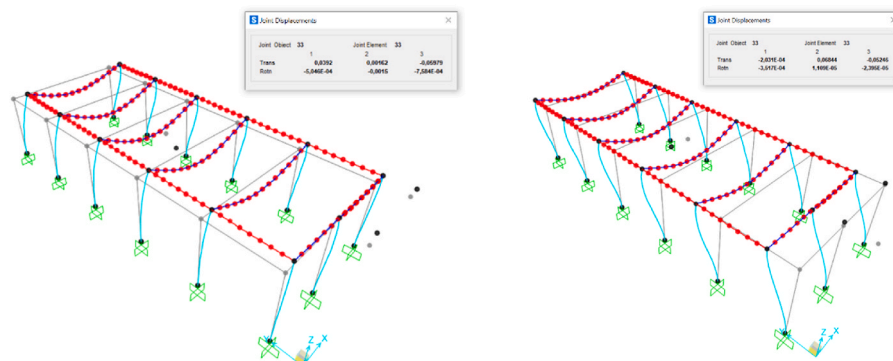
Fig. 6. Deformations of elastic static analysis in the Ex (left) and Ey (right) application of loads.

seismic shear force corresponding to the fundamental period in each direction and the mass of the structure. The mass for the G+0.3Q combination, found to be 208 tn, was used, corresponding to a base shear applied for the static elastic analysis in the two directions as per Eqs. (1) and (2). The deformations of the structure for the application of the base shears are depicted in Fig. 6.

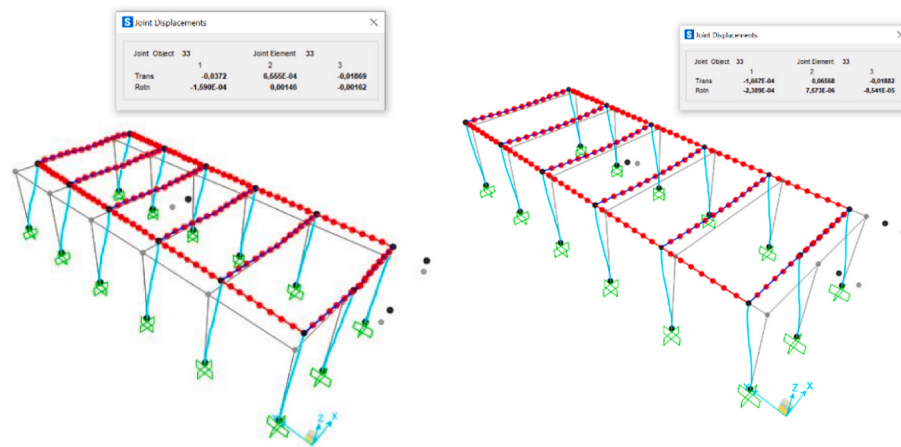
Fig. 7. Deformations of elastic modal analysis in the Ex (left) and Ey (right) application of loads.

In the case of the elastic modal analysis, the loads are applied on the structure based on the mode shapes and the response spectrum incorporated in the analysis program. The results from each mode are then combined by the SRSS method. In this case, the results indicate much lower deformations and resulting forces in the members of the structure, compared to the elastic static analysis, in both the X and Y directions, as shown in Fig. 7.

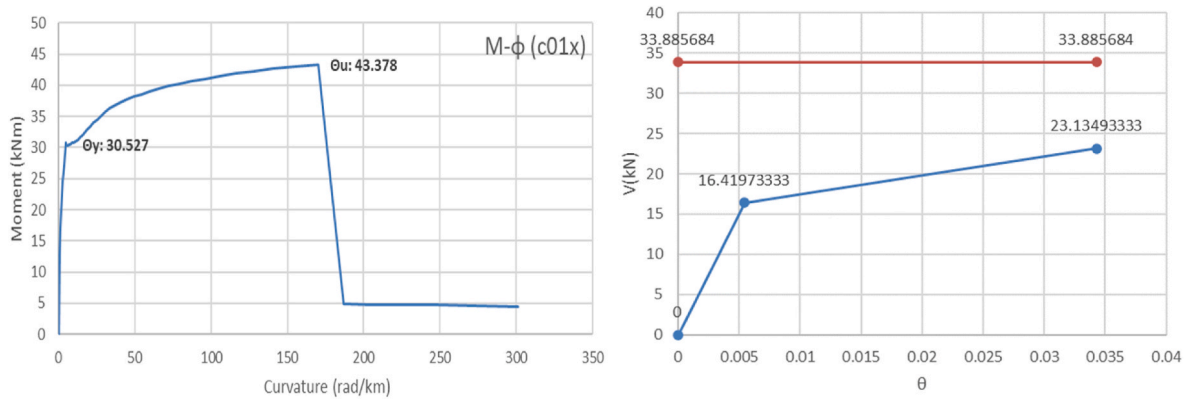
Fig. 8. Moment-curvature (left) and Shear-drift (right) for column K1 in the X-direction.

For the non-linear static analysis (pushover), plastic hinges were added at the edges of the columns, based on the moment-curvature properties of the cross-sections determined by the use of RESPONSE2000 (Bentz, 2000). The detailing, materials and axial load were imported in the program, and  $M_y$ ,  $M_u$ ,  $\phi_y$ ,  $\phi_u$  were obtained for each column (Fig. 8 left). The moment-curvature was translated into shear-chord rotation diagrams, while the shear capacity of the members based on the stirrups was compared to the yielding shear (Fig. 8 right). All the members were found to fail with a ductile manner by yielding of the flexural reinforcement. Yet, the failure mechanism of the columns initiated prior to the yielding of the beams, contrary to the well-established capacity design.

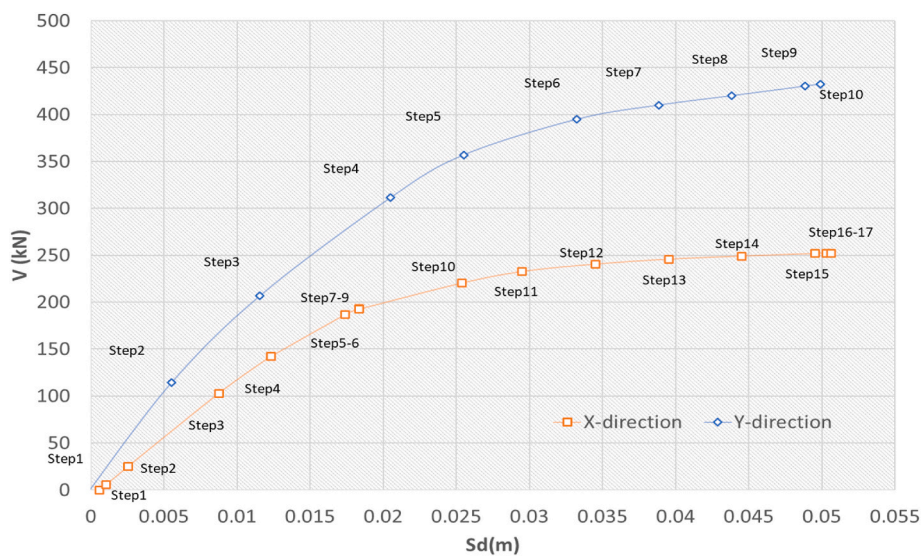
Fig. 9. Pushover curves in the X and Y direction.

The non-linear static analysis used a constantly increasing force applied on the node corresponding to the center of mass, in the X and Y directions. The displacement of the monitoring node (center of mass) was monitored for each step, along with the base shear corresponding to the sum of the shear forces of all vertical members of the ground floor. The base shear vs control node (center of mass) displacement diagram comprises the pushover curve of the structure. The pushover curves in the two directions are shown in Fig. 9. These were then bi-linearized, according to EC8 - Part 1 (Annex B) (EN1998-1, 2004), as shown in Fig. 8 (right) for the X-direction. The pushover curve gives the maximum base shear that can be obtained by the structure, the displacement capacity, as well as the demand according to the elastic design spectrum.

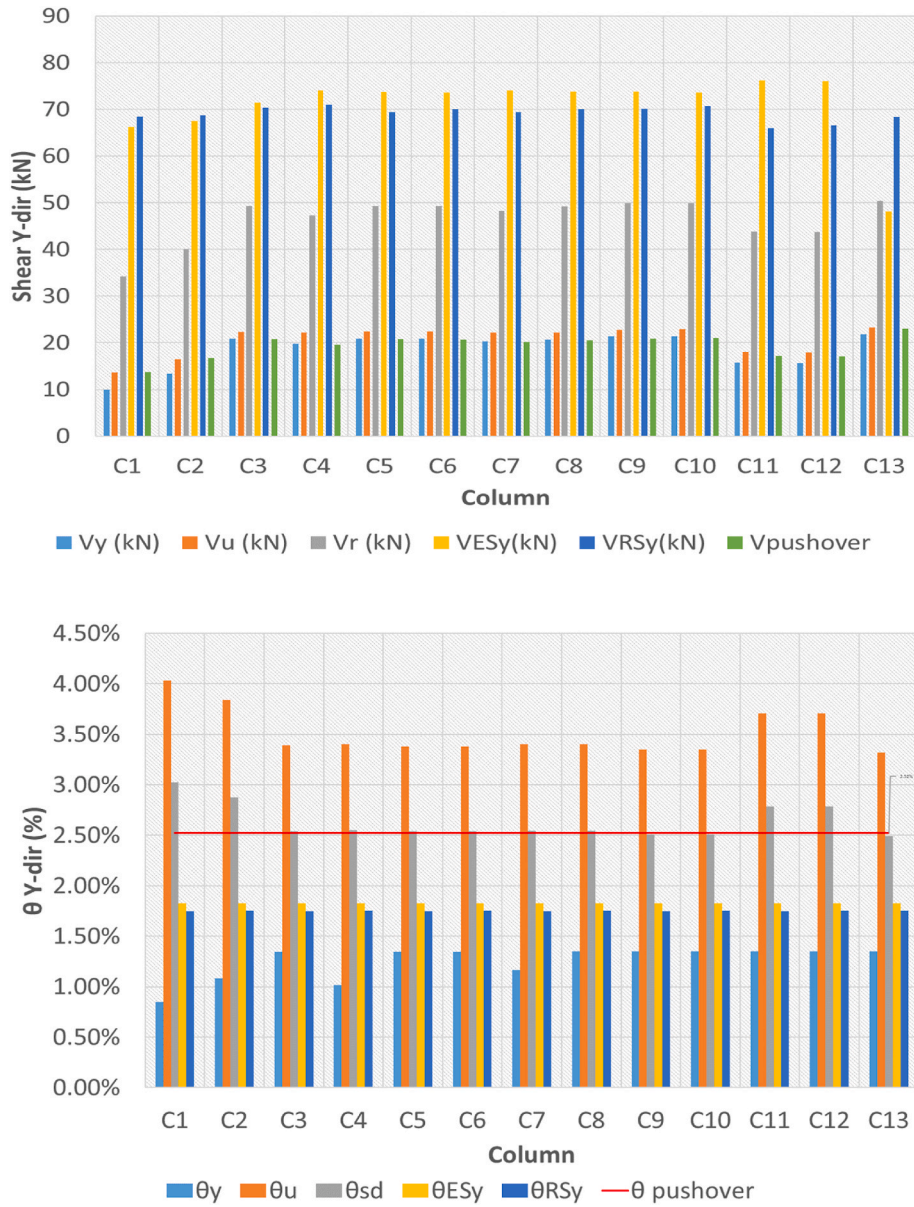
Fig. 10. Shear demand and capacity (top) and chord rotation demand and capacity (bottom).

reinforcement ( $V_y$ ), failure in flexure ( $V_u$ ) and shear failure ( $V_r$ ) was compared to the shear request, based on the three types of analysis performed: elastic static ( $V_{ES}$ ), response spectrum ( $V_{RS}$ ) and inelastic static ( $V_{pushover}$ ) (Fig. 10 top). In terms of forces, both elastic analyses resulted in failure of the columns of the structure and increased shear demand (3.5 times the capacity of the members). By adopting the aforementioned assessment methods, any potential retrofit scenarios will result in excessive demand for stiffness and strength. The lowest forces are obtained by the non-linear pushover method, as this takes into consideration the actual yielding of the cross-section and the redistribution of load to the rest of the members.

The opposite applies for the case of the chord rotations, as shown in Fig. 10 bottom. The pushover analysis shows that most of the columns will be required to reach their Life Safety ( $\theta_{sd}$ ) threshold in the design seismic scenario.

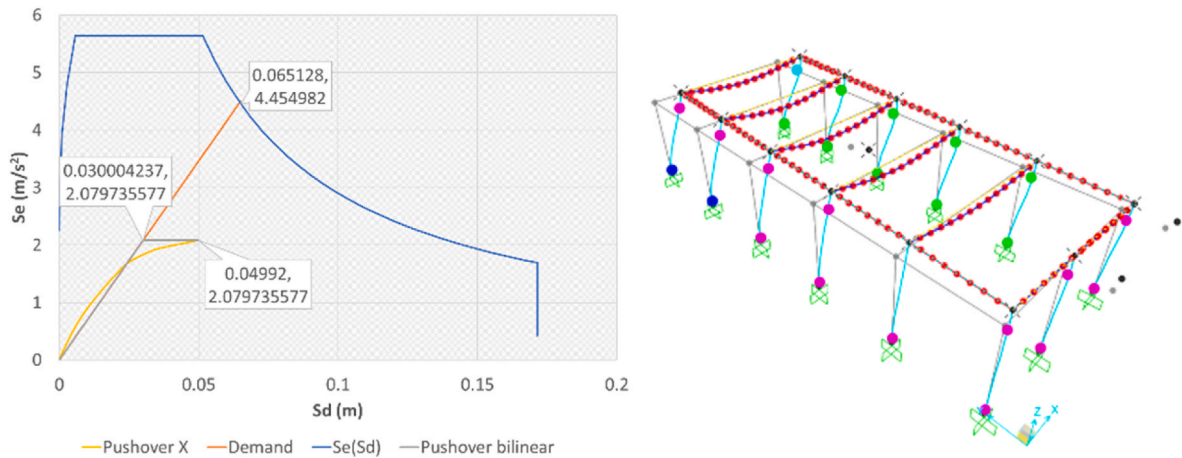
Fig. 11. Pushover curve and seismic demand (left) and formation of plastic hinges at the end of pushover (right) for the X direction.

Other than the correct redistribution of loads by this inelastic analysis, compared to the two elastic ones, the pushover analysis (Fig. 11 left) also sheds light to the prevailing type of failure that seems to be the formation of a soft storey mechanism (Fig. 11 right), which leads to collapse of the structure, prior to the members reaching their full deformation capacity. Even though the ductility demand in this case,  $\mu_{dem} = 2.33$ , is much closer to the ductility capacity,  $\mu_{cap} = 1.66$ , the proposed retrofit scheme would still have to increase the ductility of the structure by 1.5 times in order to prevent collapse.
